Jem n I Properties LLC

Property Inspection Report

1528 Sunshine St., Sarasota FL, 34343
Inspection prepared for: Mary Smith
Inspection Date: 3/4/2009 Time: 10:30
Age: 25 yrs Size: 1926 Sq Ft +/-
Weather: Clear
No Rain within 72 hrs. External temp 78 F
Owner, Seller and realtor in attendance

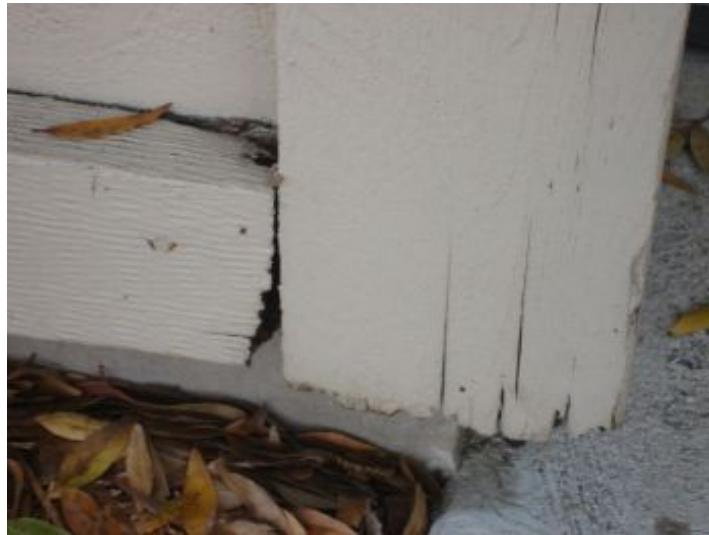
- **Dry Rot observed on lower portion of several trim pieces**

Dry rot in exterior trim

- Several types of siding were noted. T-111 on the North and East side. Hardie Board on South side. Wood and decorative lumber on the front/West side.
- **Dry Rot was detected on the lower portions of the siding on the Front of structure and various trim pieces. Recommend review and repair by qualified tradesman.**

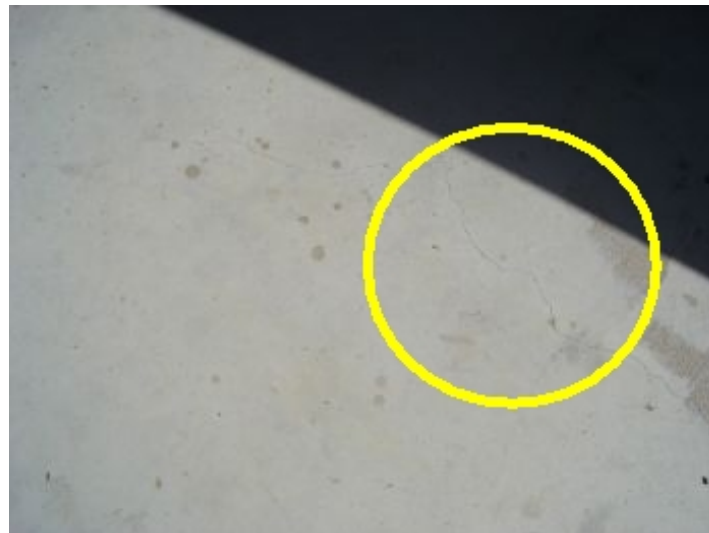
Minor settlement cracks in rear Lanai

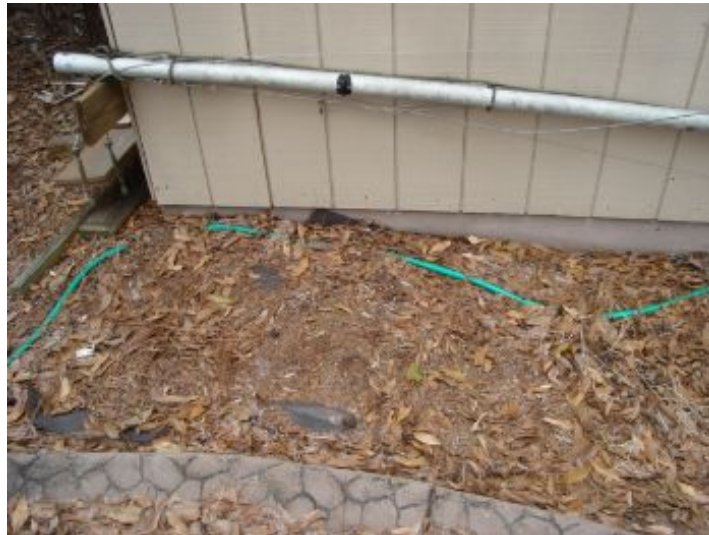
- Trees/shrubs are overgrown and in contact with structure. Recommend trimming back foliage a minimum of 12 inches of clearance. This will provide adequate circulation to dry out structure as well as limit potential organic growth and help prevent entry by insects and rodents through cracks and crevices.
- **Soil is high at foundation. This presents undetected entry into structure by Wood Destroying Organisms. Repairs are needed to allow a minimum of 6 inches of seperation between soil and the bottom of the siding to allow inspection and detection of termite mud tunnels.**

Grade is too close to siding, may cause moisture to wick into siding.

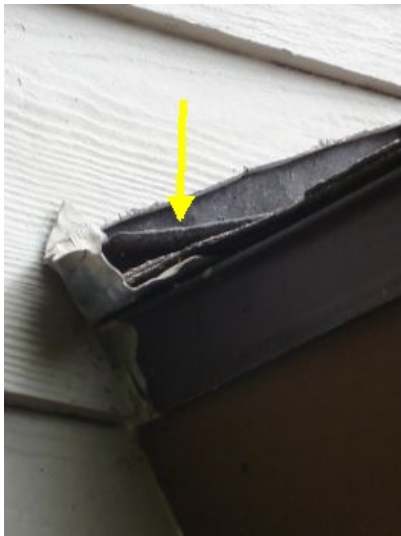
- **Kick out flashing is undersized on Southwest side of house. No kick out flashing in front of house.**
- **Exposed underlayment**
- **Recommend further review and repair of deteriorated/improper flashing by a Qualified roofing Contractor.**

Undersized flashing, exposed sheathing

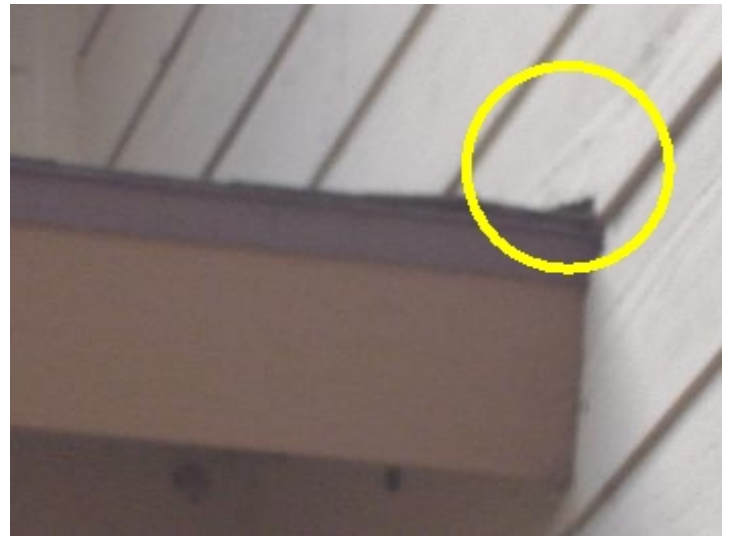
Missing kick out flashing on Northwest side of roof

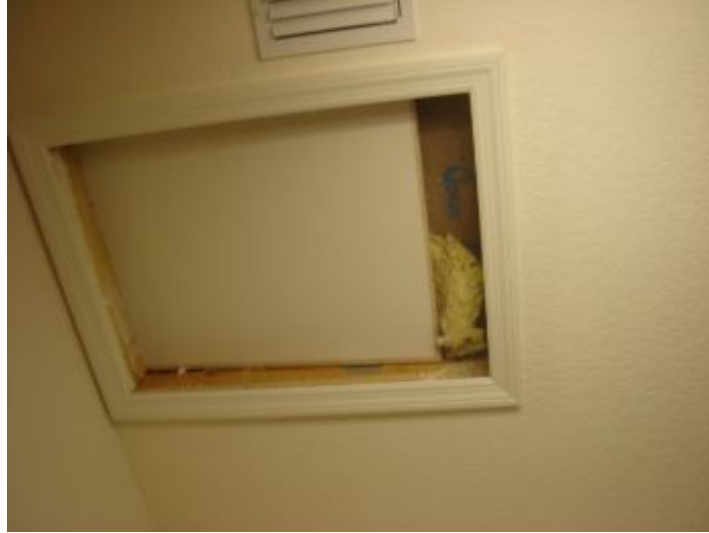
- **Unable to inspect due to blocked access**

Blocked access to attic

Observations:
 • **Attic access was blocked. Unable to determine. Recommend attic hatch to be cleared for future inspection.**

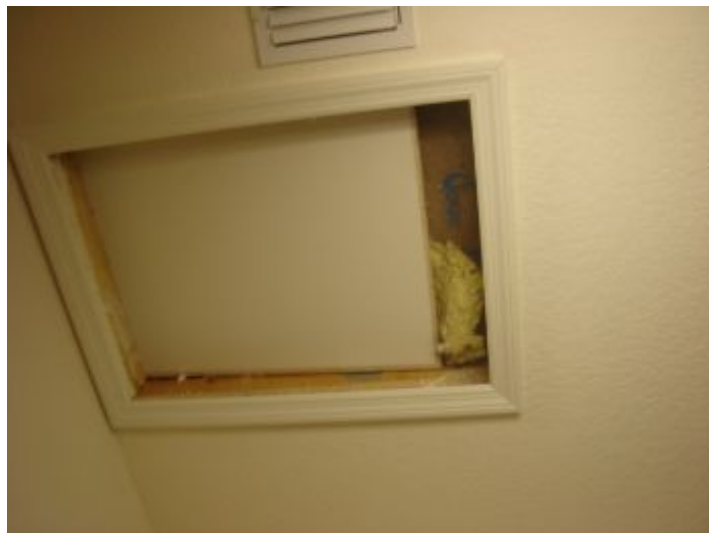
Blocked access

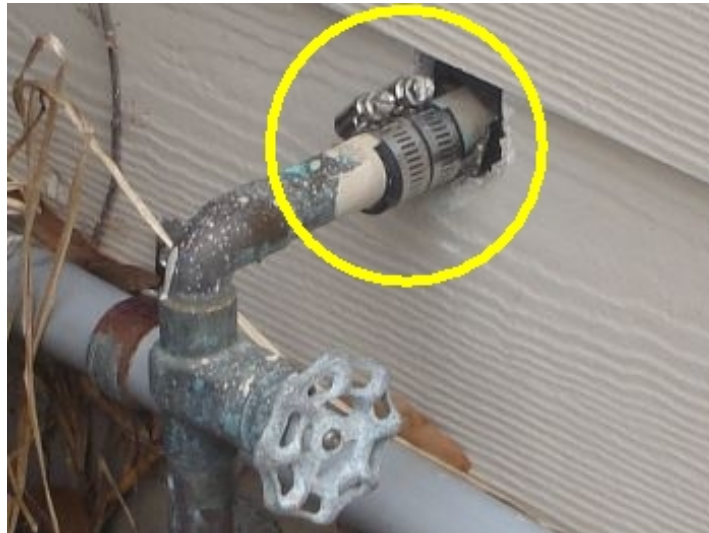
- **Unprofessional repairs noted at supply lines at one or more locations observed. Recommend review and proper repairs by a Qualified Plumber.**

Unprofessional repair. Water Main shutoff

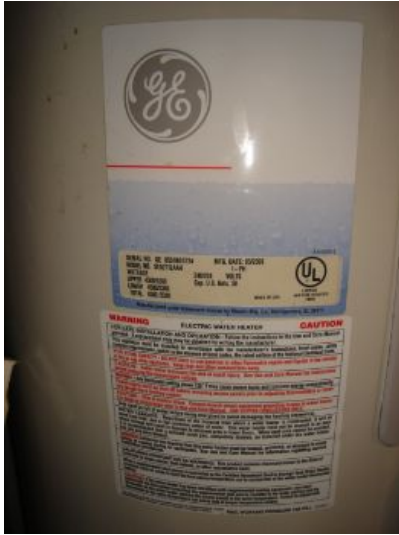
- GE Mnfg date 5-2008. Please note signs of previous leakage at the supply side of the water. Recommend further monitoring.

Water heater data plate

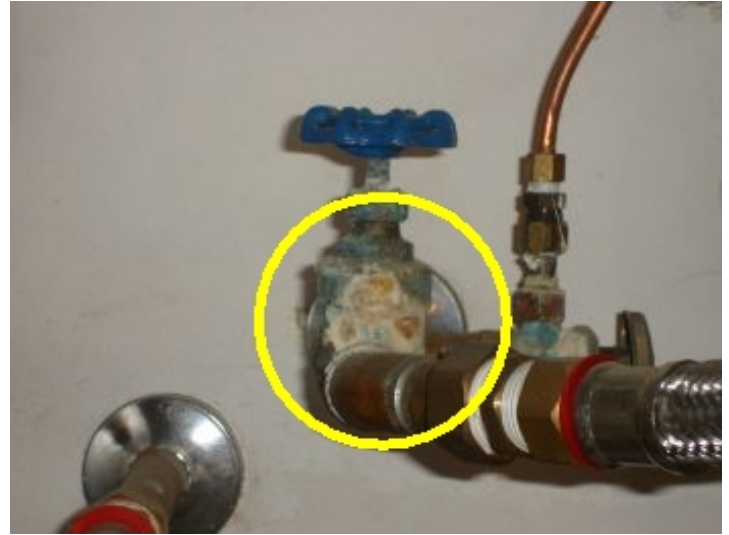
Calcified remains of previous leak

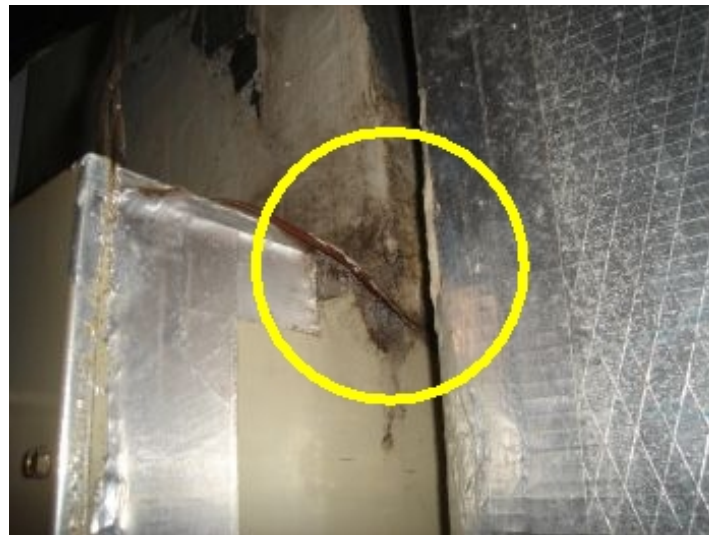
- HVAC Unit was in cooling mode.
- **Organic type substance was observed on the exterior of the air handler. Recommend further evaluation by qualified tradesman.**

Organic type material on exterior of air handler

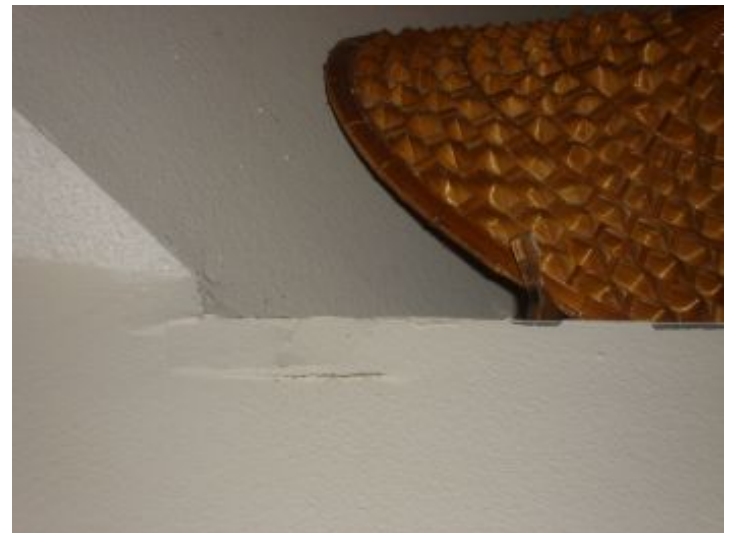
- Lifted tape seam/s at one or more locations observed.

Detached/lifting tape seams

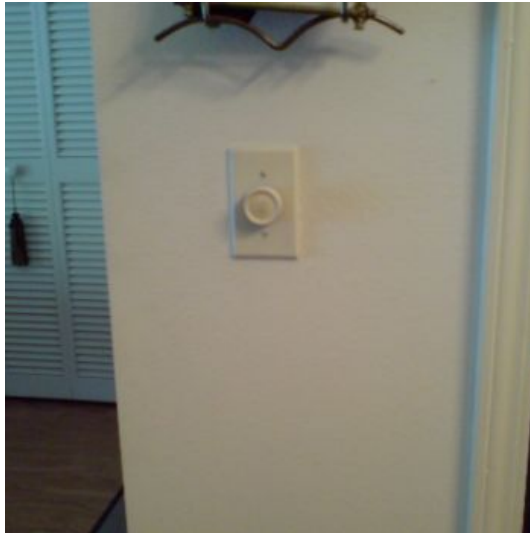
- **An overheated dimmer switch was located in the dining area. Recommend repair by Qualified electrician**

Dimmer switch in living area

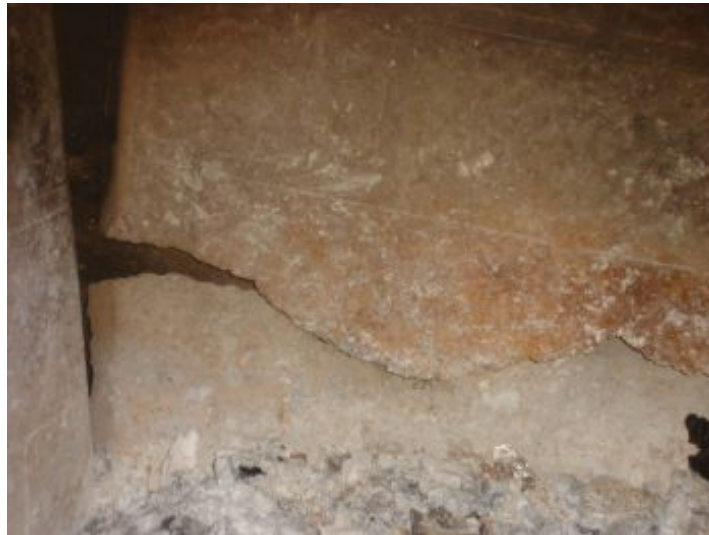
• Large cracks present on rear refractor DO NOT USE FIREPLACE until repairs have been made.

Damaged rear refractor
